## Non-Structural Mitigation - Earthquake

### Full Mitigation Best Practice Story

#### *Thurston County, Washington*

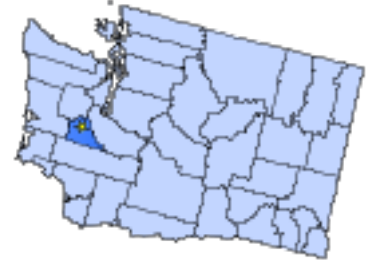
The Mallingers water heater was several years old and needed to be replaced. During installation, earthquake strapping was recommended by the installer. The Mallingers agreed, and flexible gas lines were installed and metal strapping was used to secure the water heater to the wall studs.

Four years after the securing of the water heater, the Olympia area was shaken by a 6.8 magnitude earthquake. The shaking was severe enough at this house to cause items to fall from shelves, a ceiling light fixture to fall, and the foundation to crack. The simple preventative action taken to secure the water heater, at a cost of about \$10, protected a home valued at \$250,000 from fire. The Mallingers also have earthquake insurance.
